Lose the grime see growth rates climb

Name: Andrew Freemantle, Kenniford Farm
Location: Clyst St Mary, Devon
Farm size & enterprise: 300 sows breeding to finishing split site production

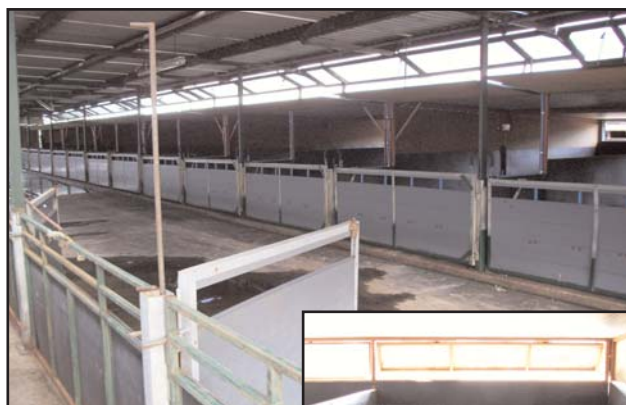
Pre C&D

Kenniford Farm breeds and takes progeny up to 45 kg after which they are moved to a separate finishing site a few miles away. Before the intervention the finishing site was a continuous flow system and had no option for all-in all-out by pen, thus no cleaning and disinfection (C&D) had been carried out for the previous two years. Although the building was only 10 years old the owner decided that a deep clean was needed; the buildings were tired and the pigs were not performing to their potential.

Cleaning was "top to bottom", wood was preserved, floor edges were re-concreted and steel work repaired.
